Milestone Inspection Report

KEG File: 21RS-0672
December 12th 2022
FINAL COPY

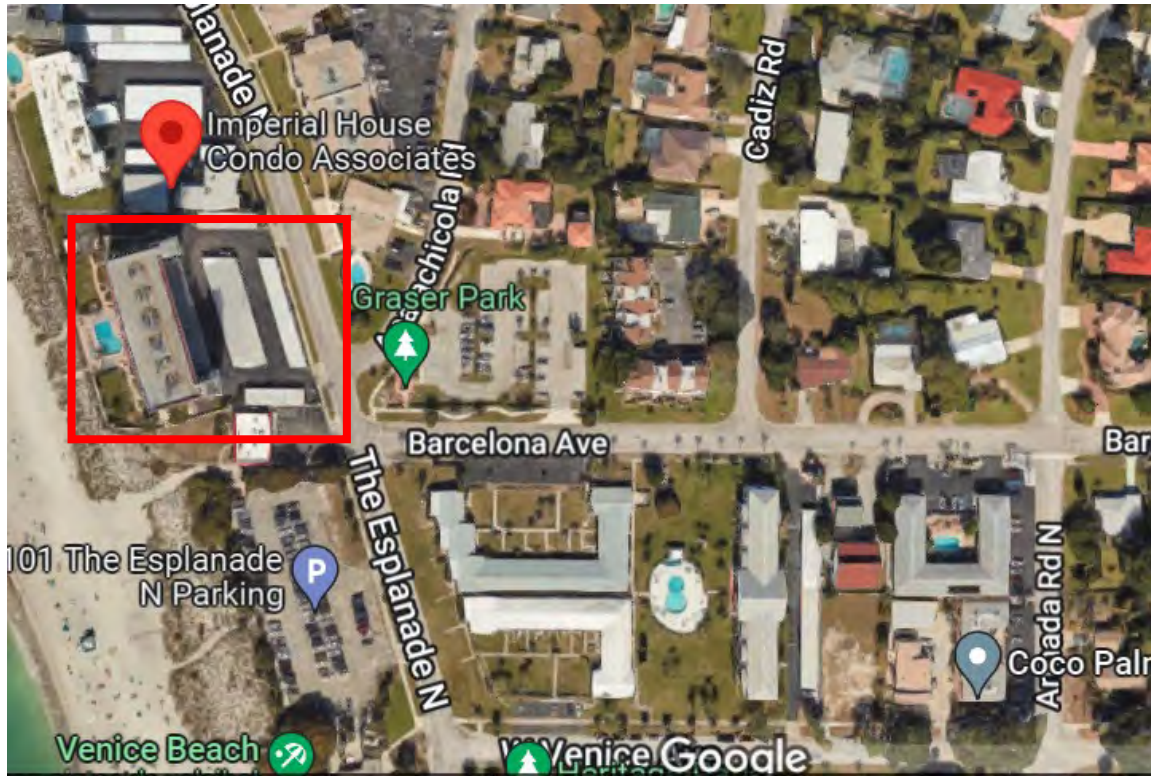
Aerial View of Gulf Shores from Google Maps

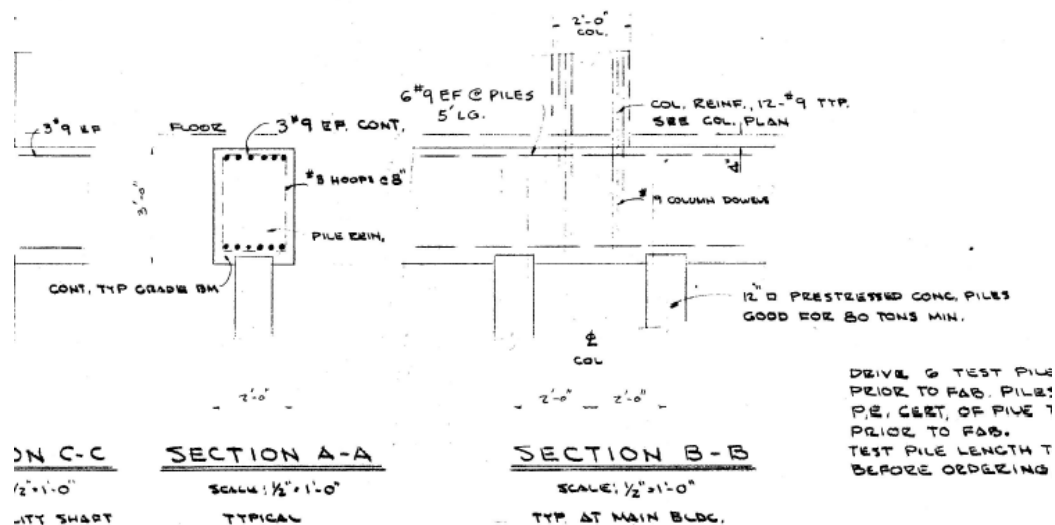
Figure 3 Foundation from drawings at Gulf Shores

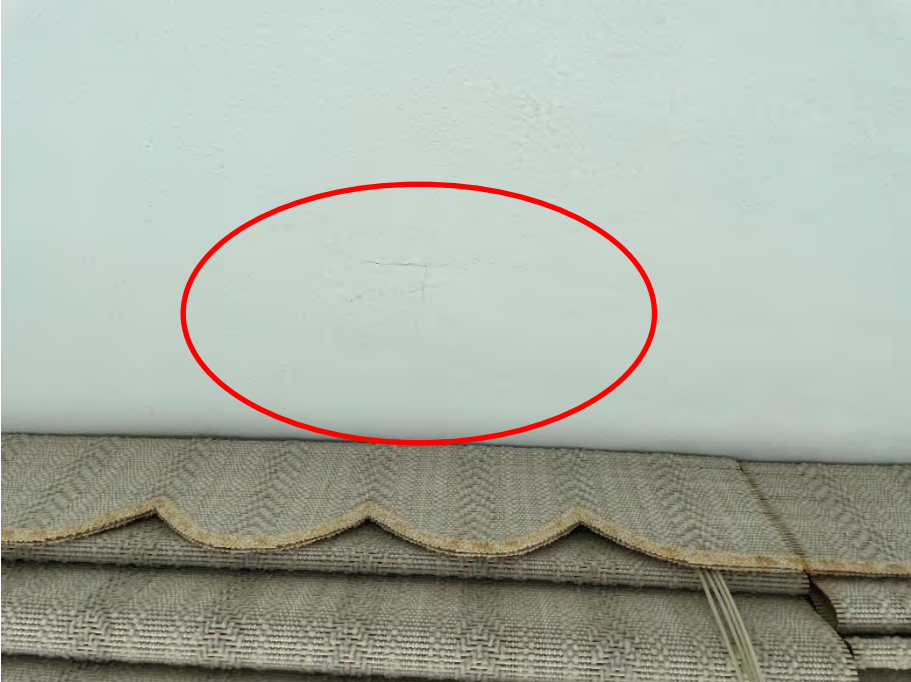
Figure 19 fine cracking at balcony ceiling

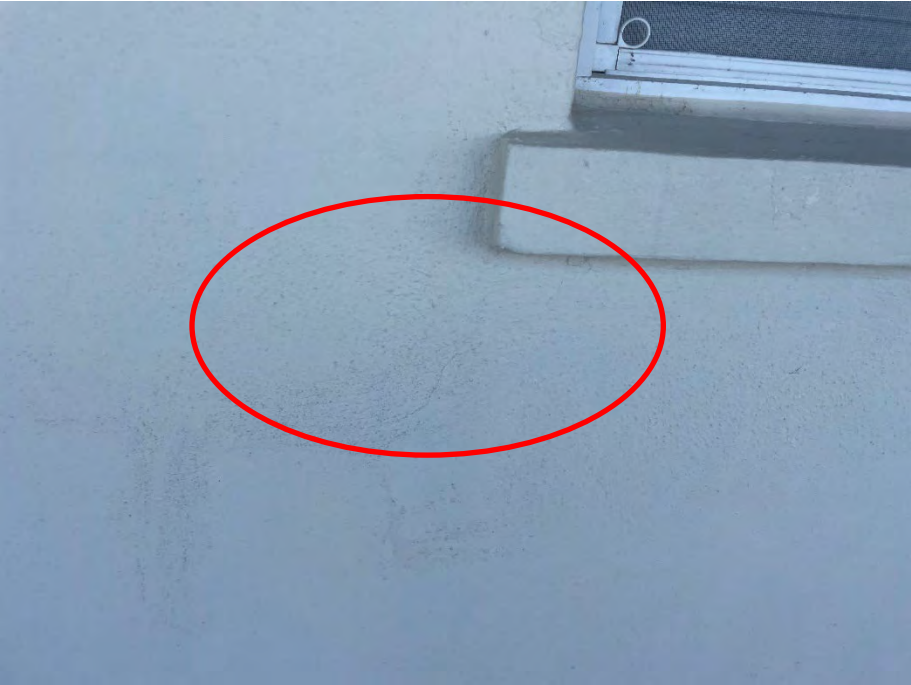
Figure 20 fine cracking at window sill

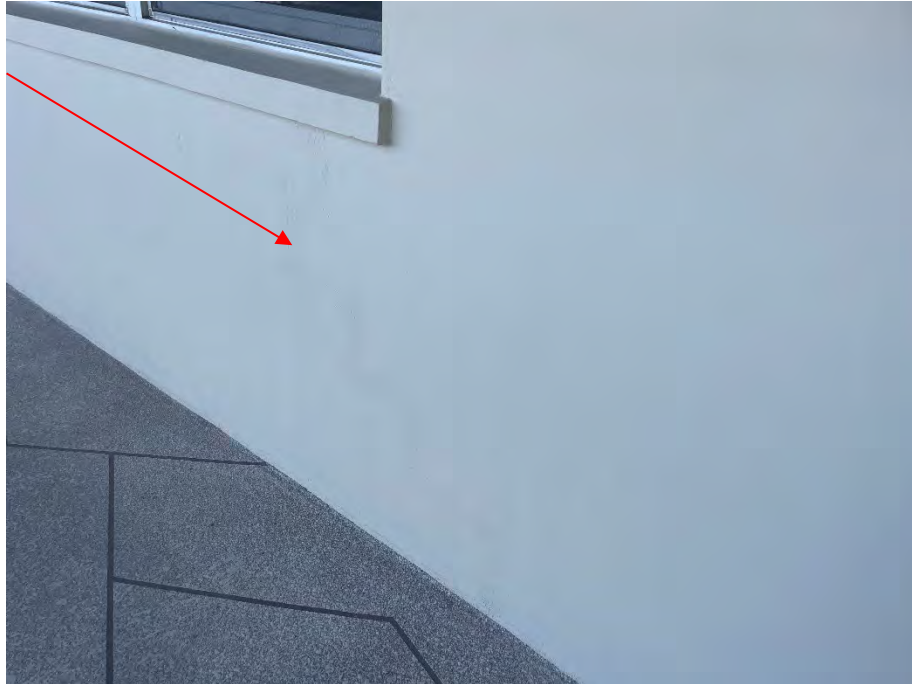
Figure 21 fine cracking at CMU at all elevations of walkways

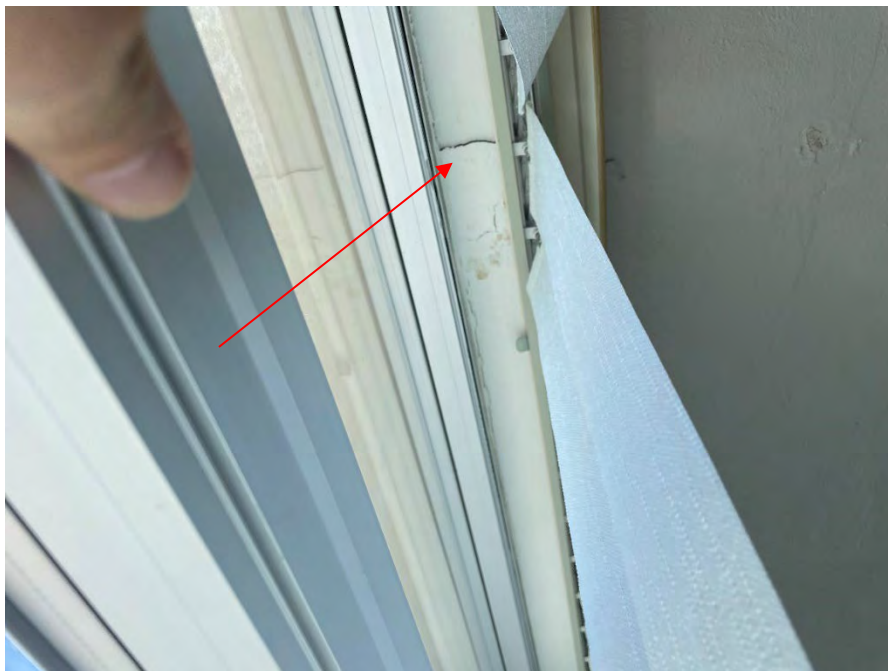
Figure 22 Balcony slab cracks observed at Unit 204

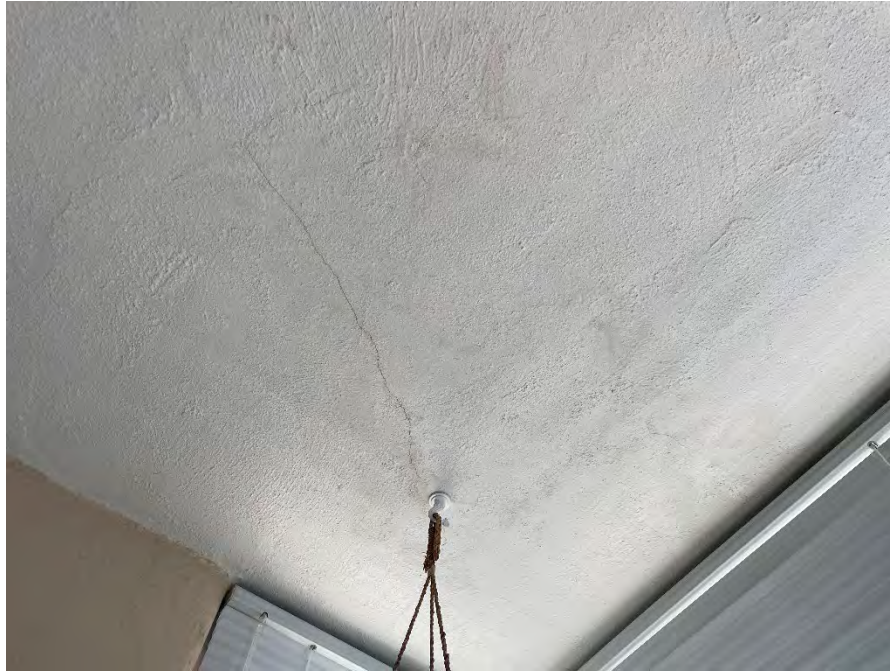
Figure 23 Balcony ceiling cracks observed at Unit 406

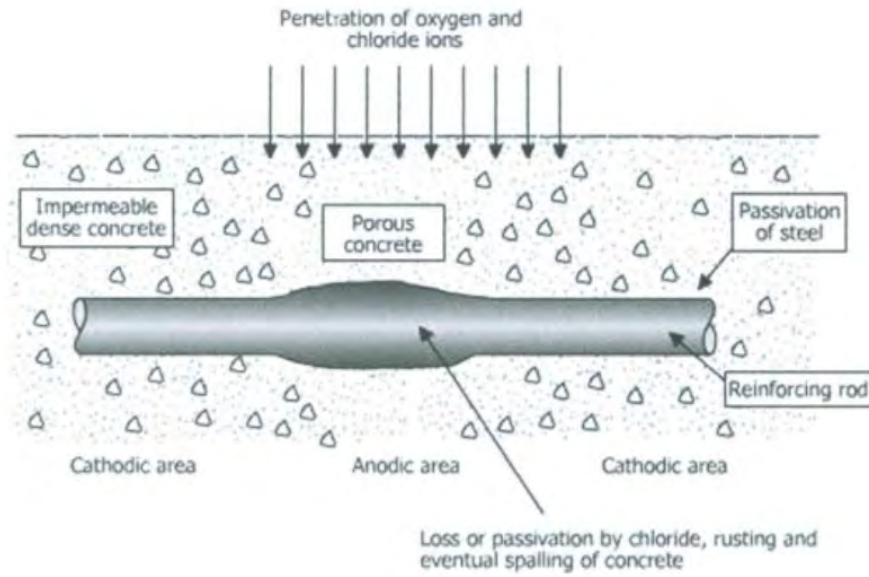
Figure 24 Corrosion of rebar

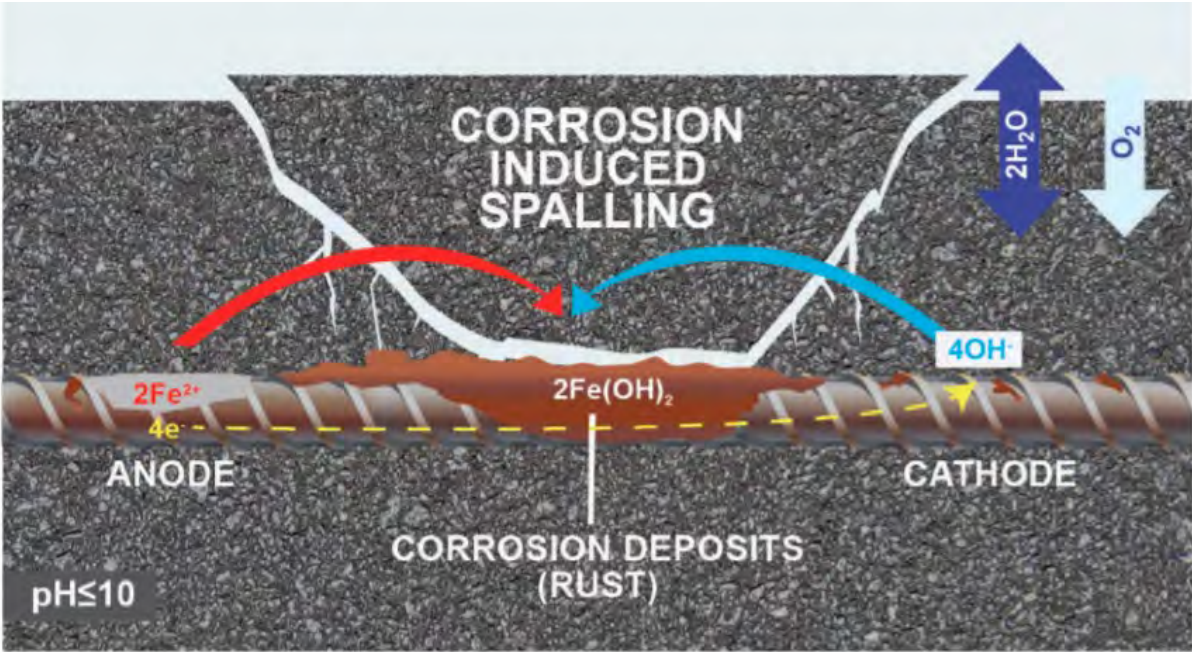
Figure 25 Before Halo Effect

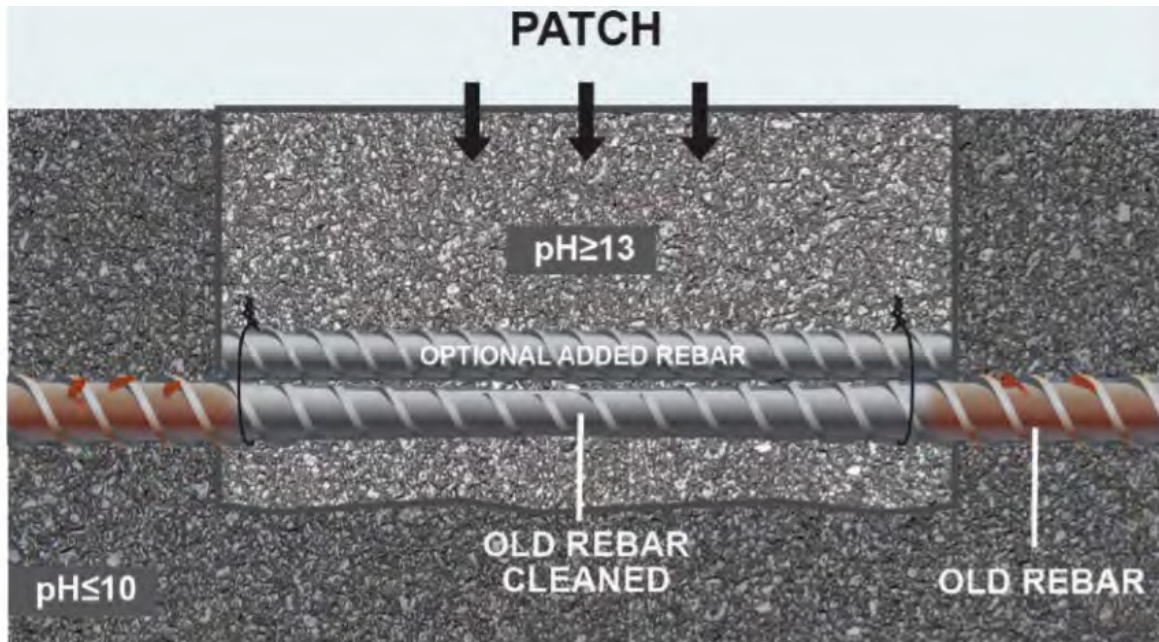
Figure 26 Ring anode corrosion

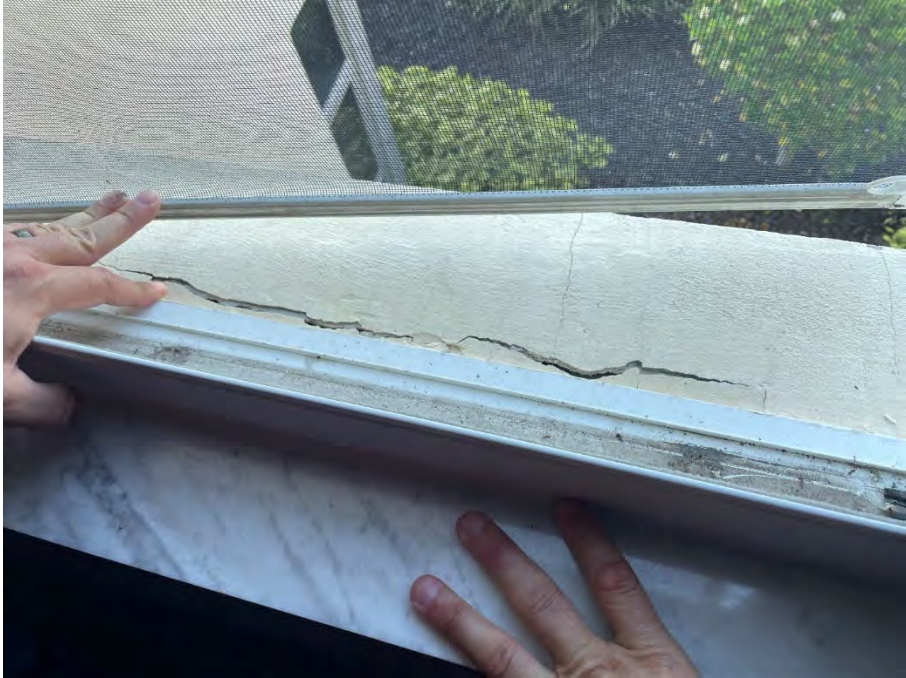
Figure 27 Typical Window Sill spalling

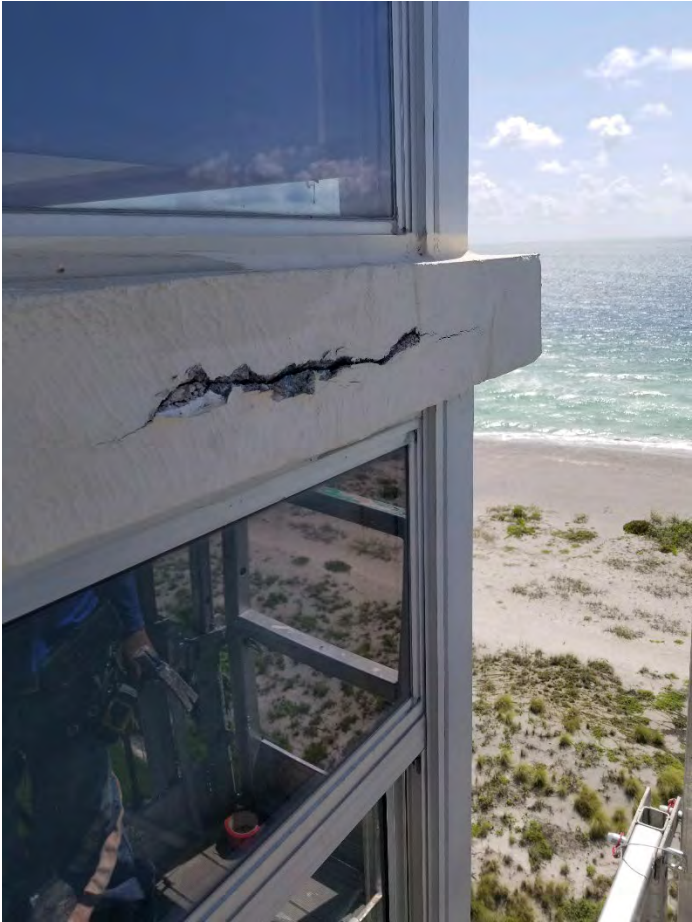
Figure 28 Spalling at slab edge

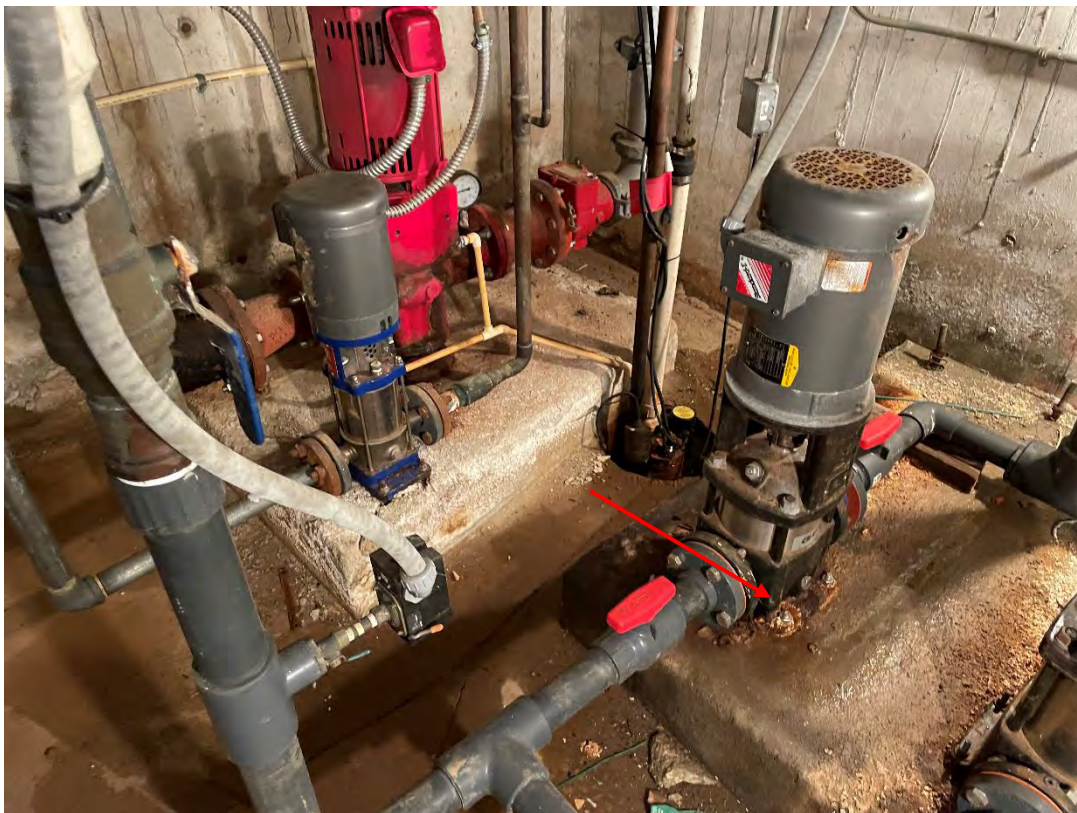
Figure 29 Pump room with corrosion on fasteners

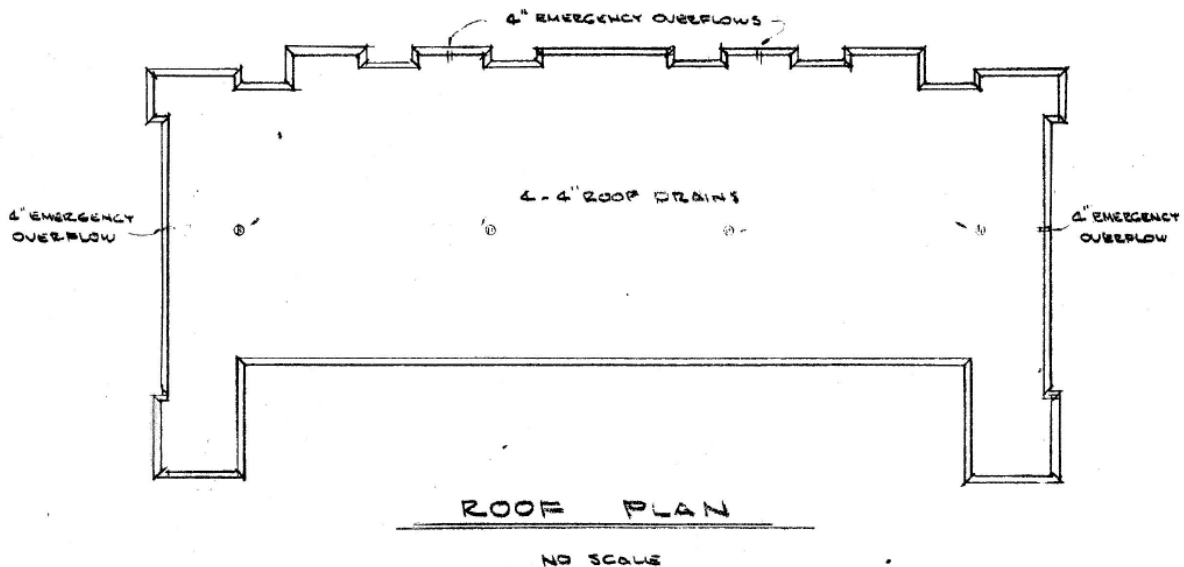
Figure 30 Roofing Plan at Gulf Shores

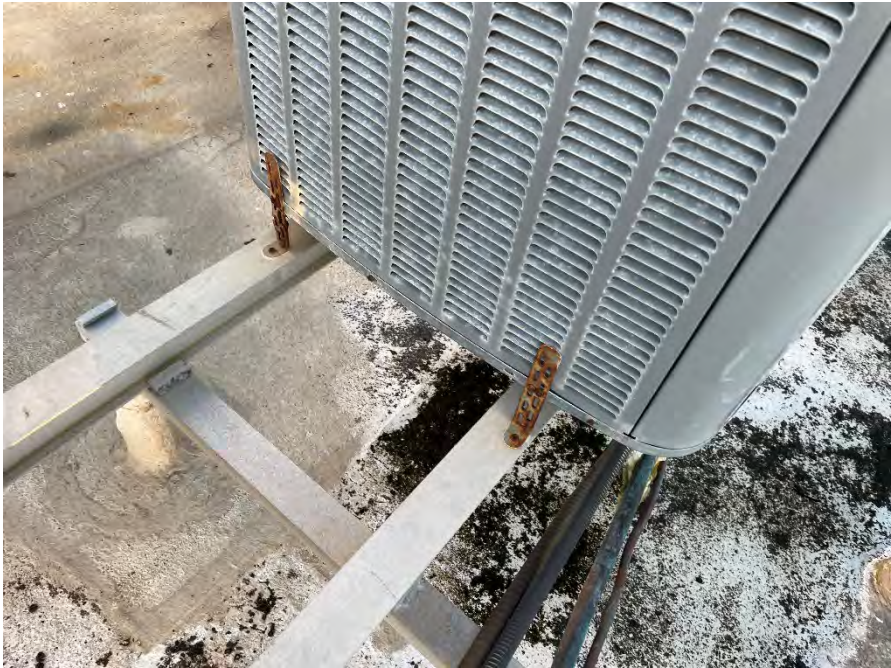
Figure 34 AC brackets appear corroded - owners responsibility to address as told to Karins by Gulf Shores

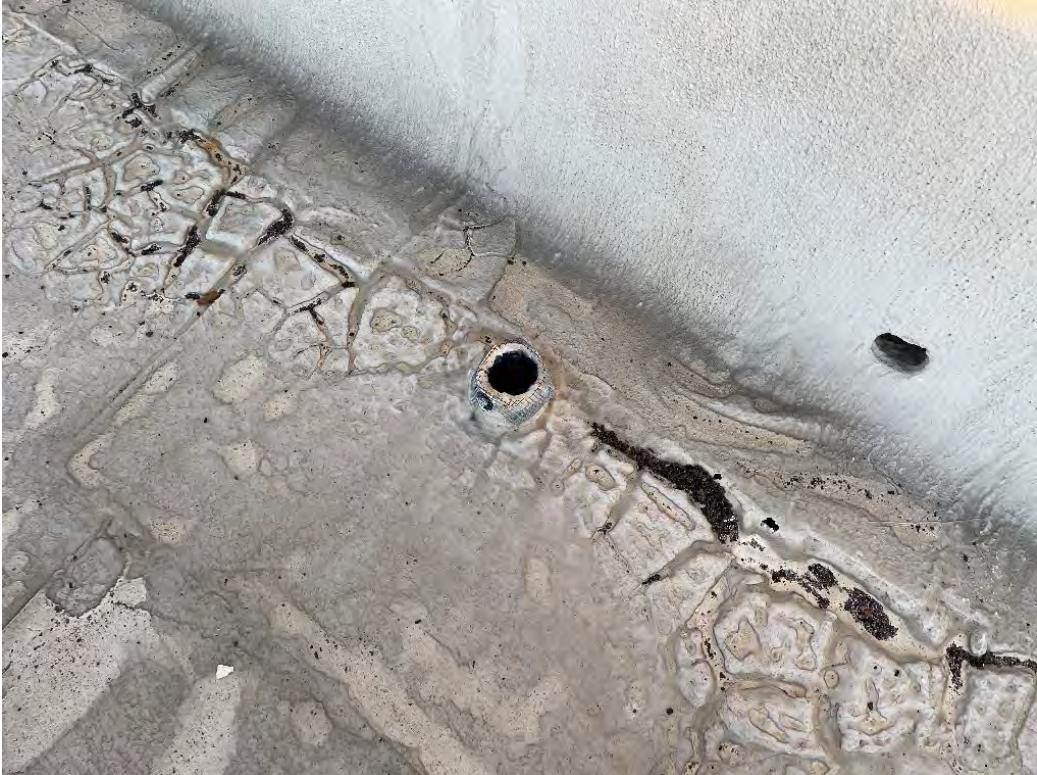
Figure 35 Roof Coating appears to be gatoring - roof membrane does not appear to be cracked

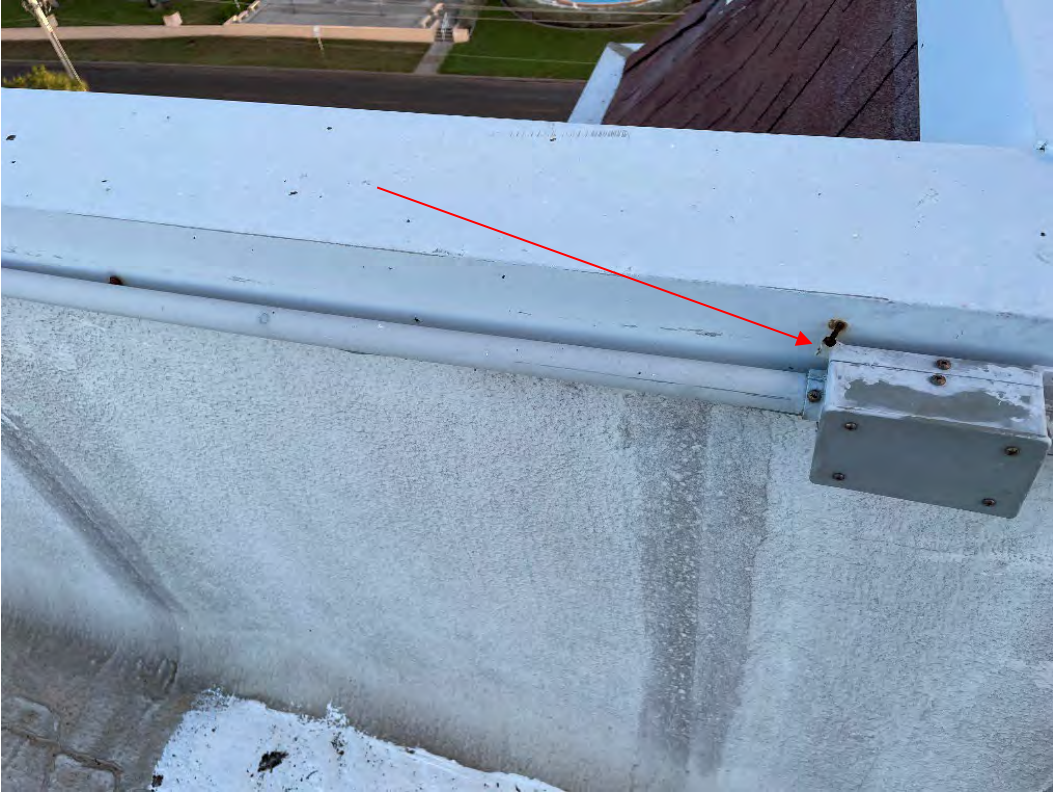
Figure 36 Loose fasteners are letting in water at coping flashing

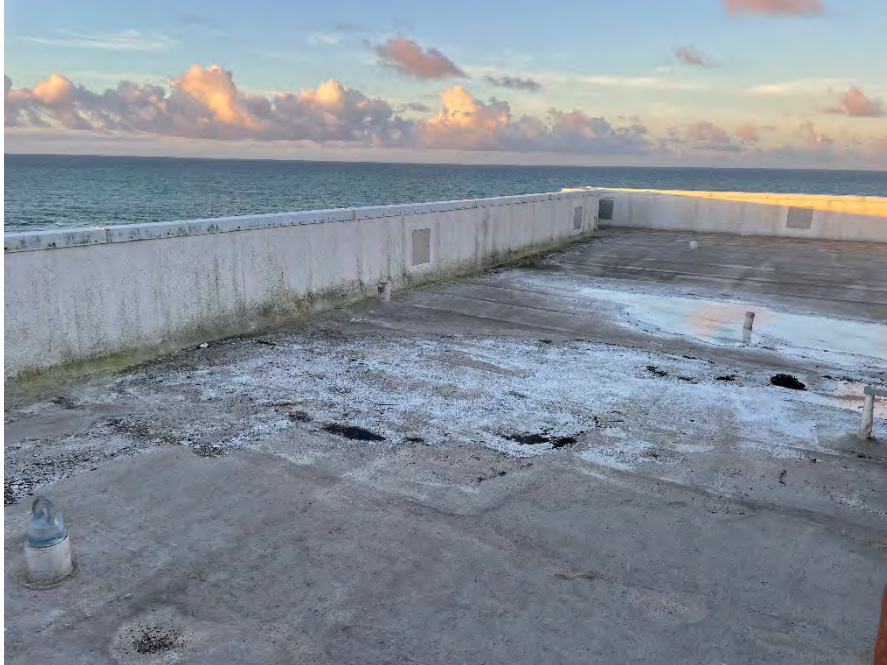
Figure 37 Roof appears dirty with residue from standing water

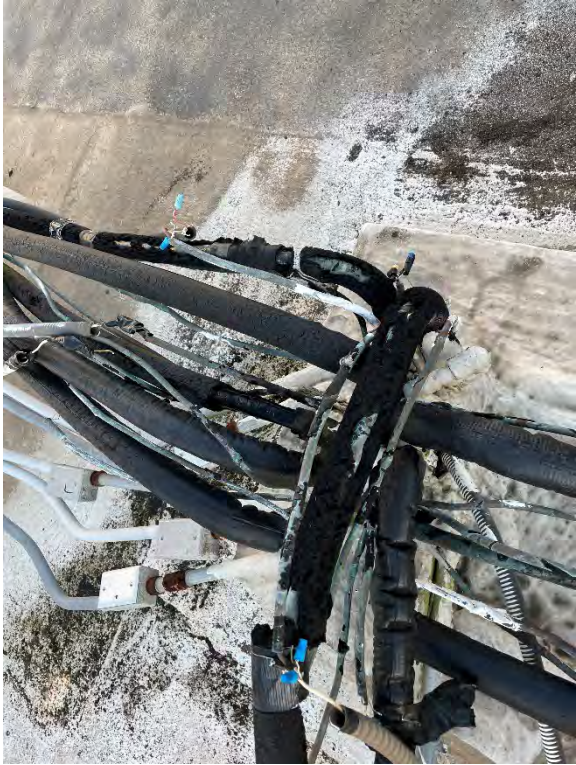
Figure 39 AC Line sets appear deteriorates

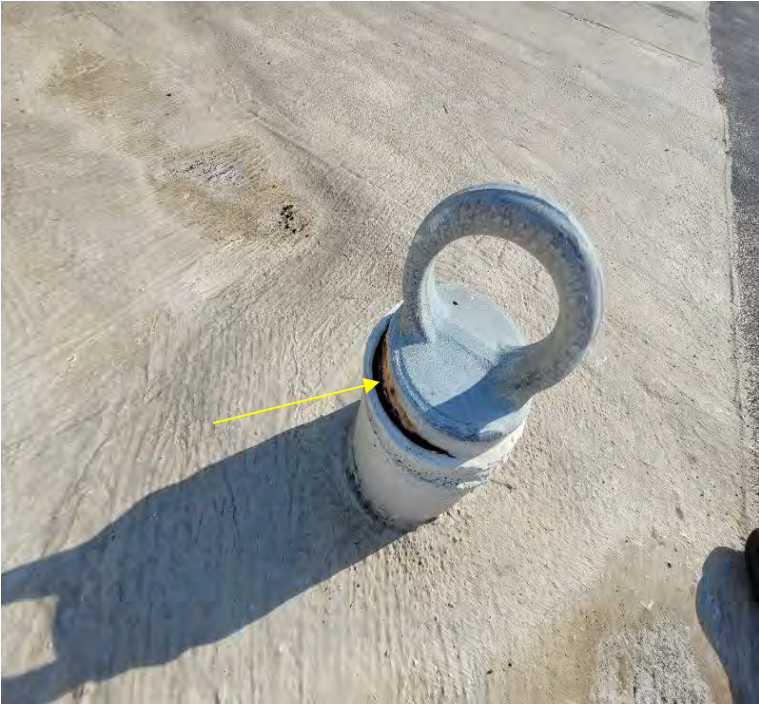
Figure 40 Open area at penetration to be sealed to prevent water intrusion

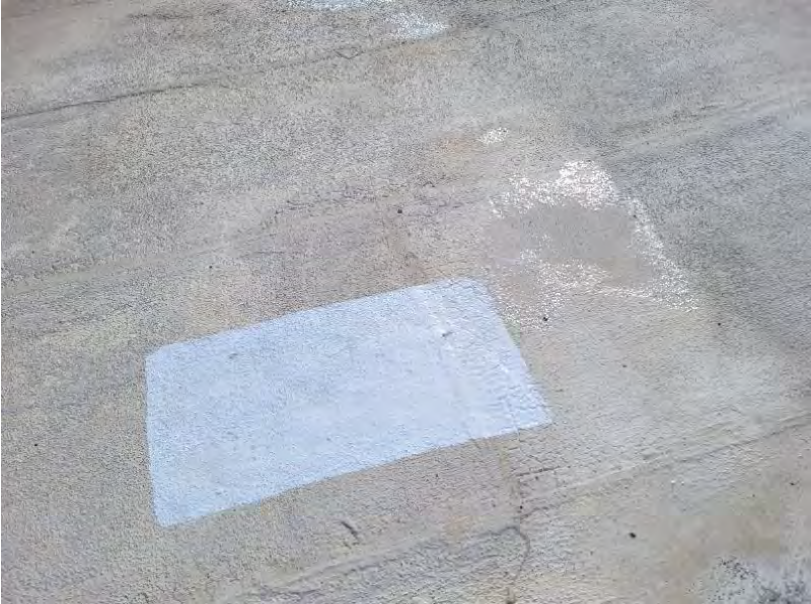
Figure 41 Previous repair made to roof

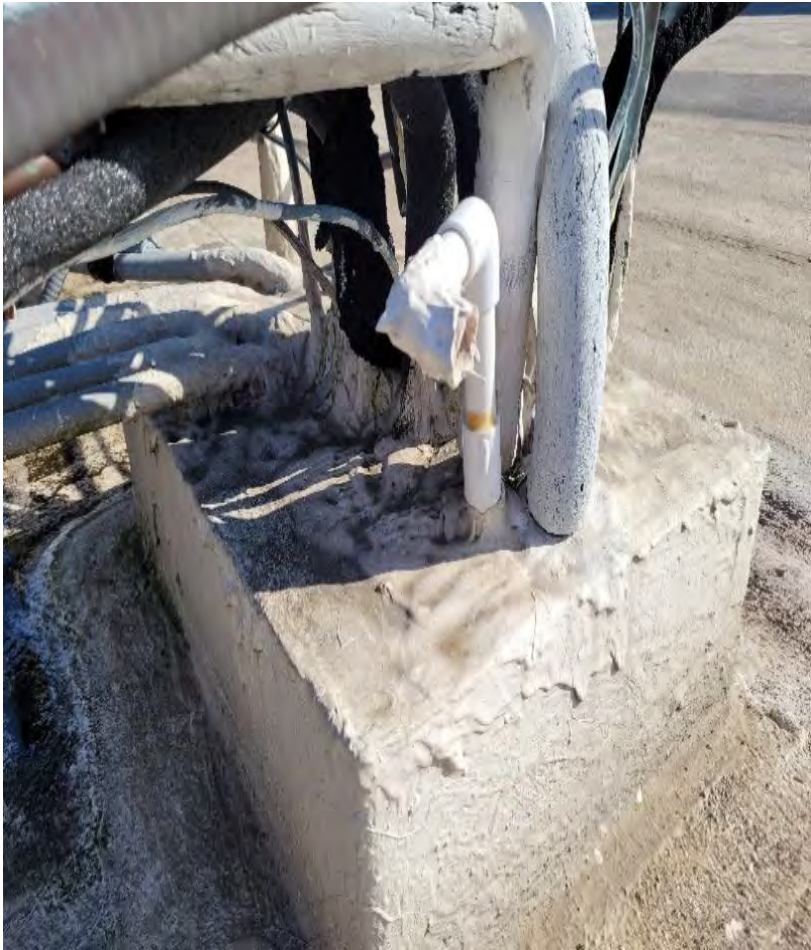
Figure 42 A/C mechanical equipment insulation showing deterioration

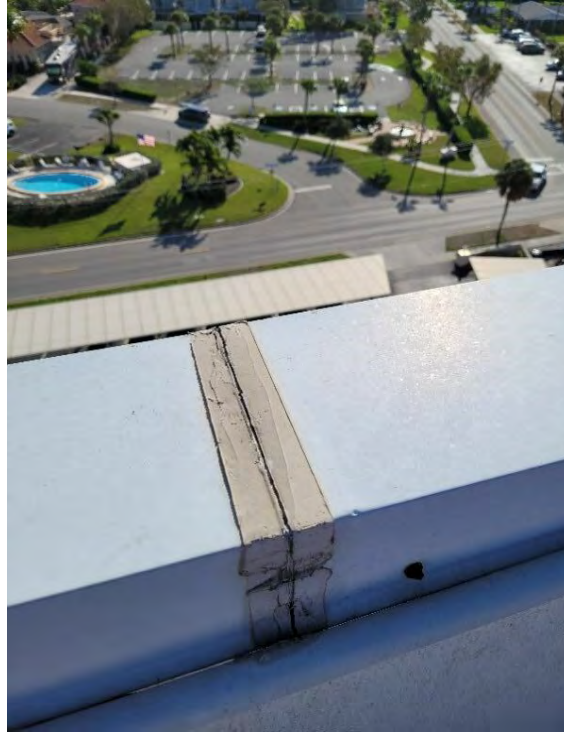
Figure 43 Recommend sealing coping seams

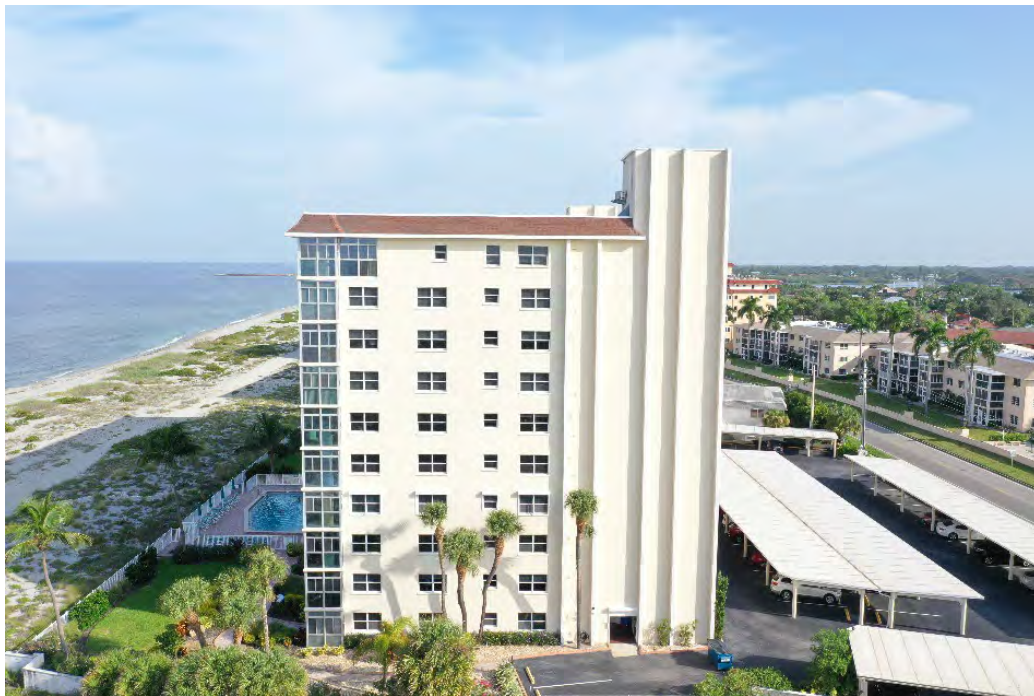
Figure 48. General View of Stucco and Paint

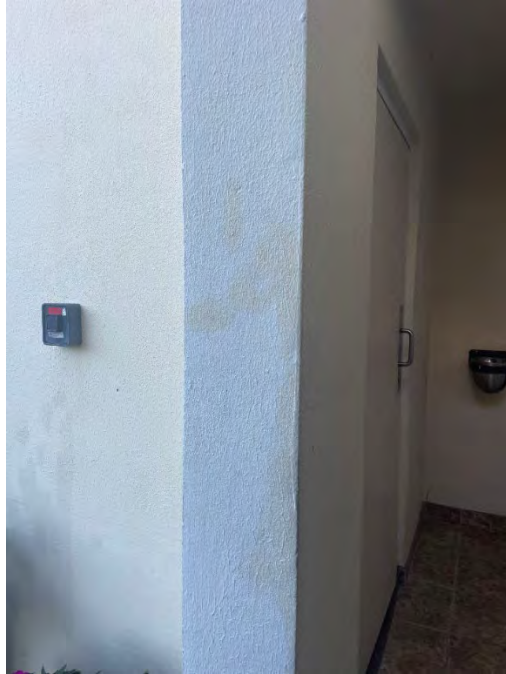
Figure 49A. Previous repairs with mismatched colors

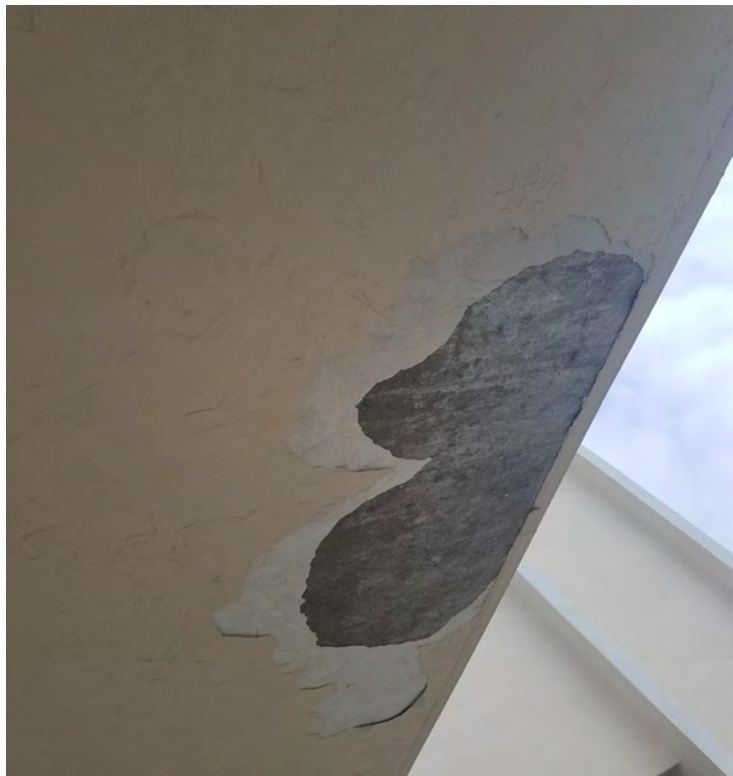
Figure 50B. Hurricane Ian stucco damage on 10th floor

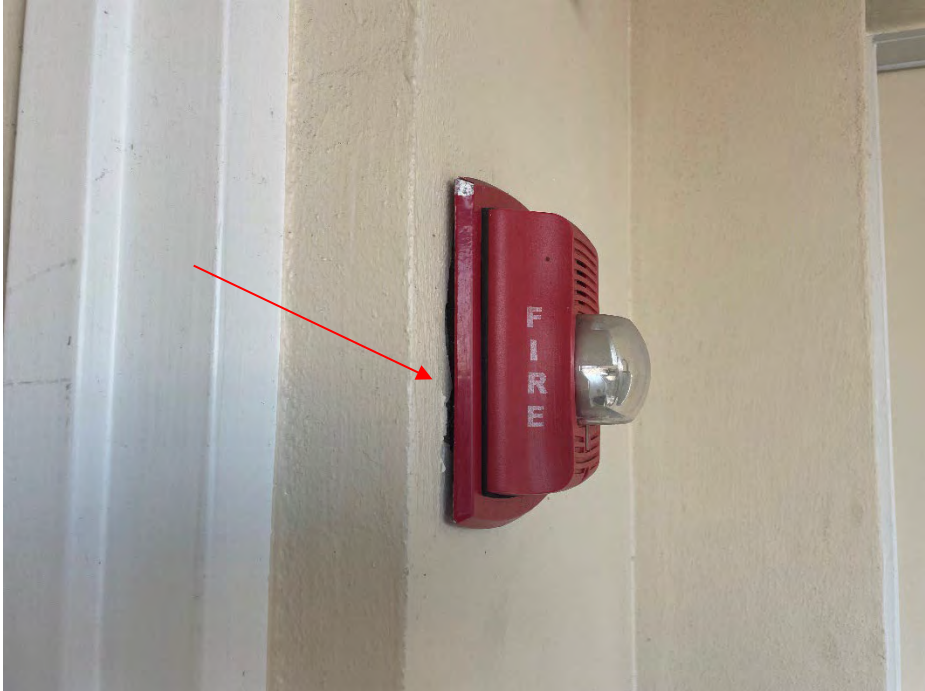
Figure 51. Protrusions lacking sealant

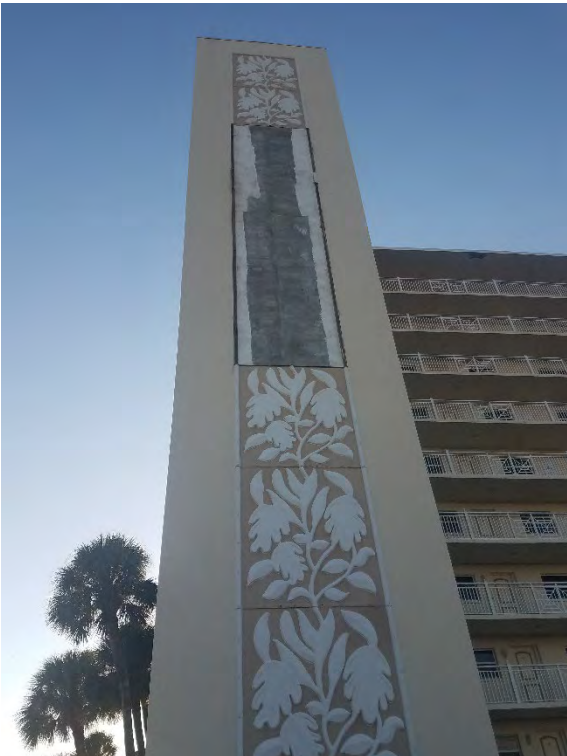
Figure 54B. Fiberglass decorative plates damaged from Hurricane Ian

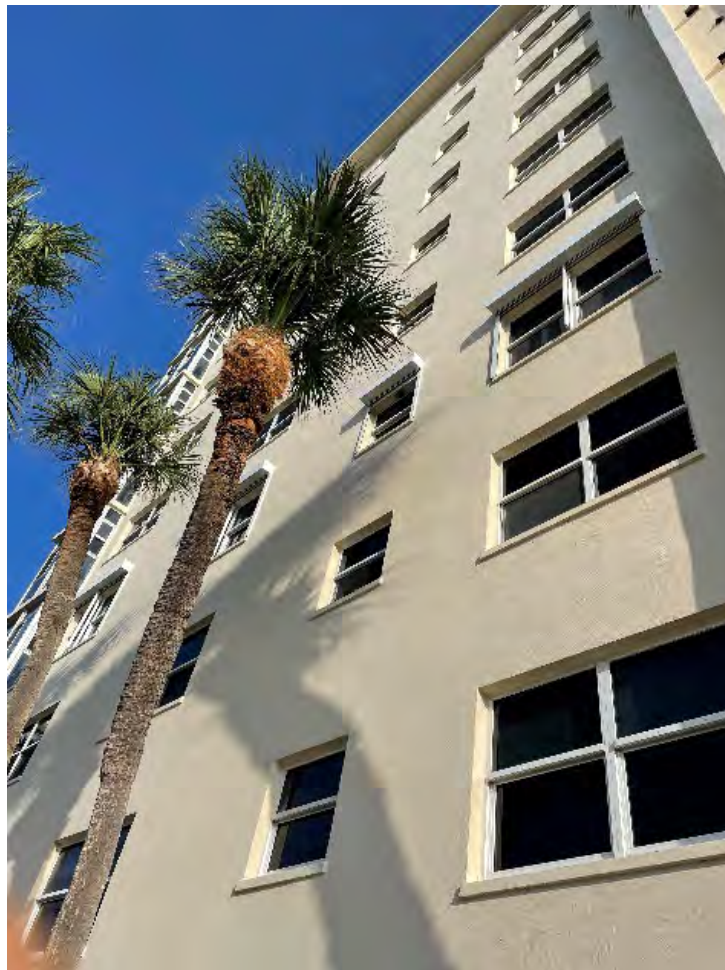
Figure 55. Windows and Window Sills at Gulf Shores

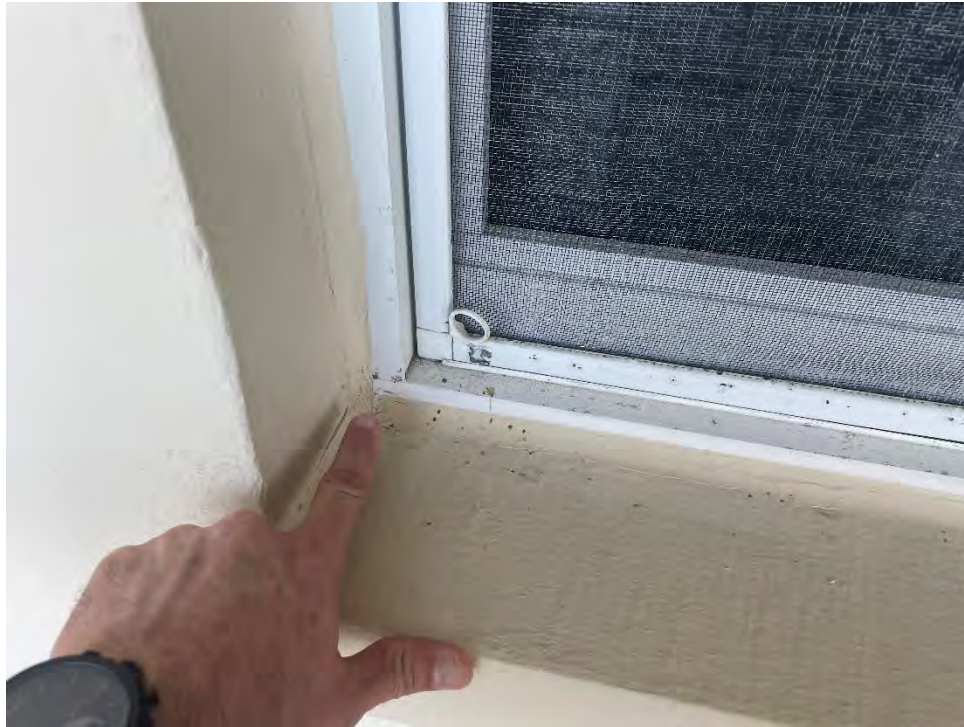
Figure 56 Exterior Sealants appear adequate on walkways.

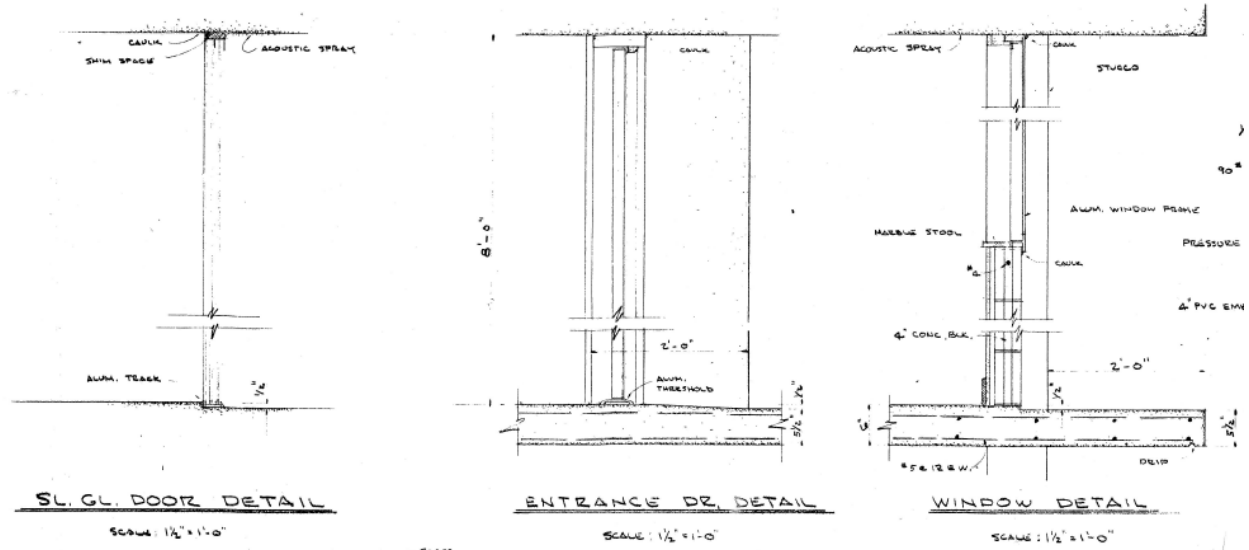
Figure 57 Windows on Balconies go floor to ceiling

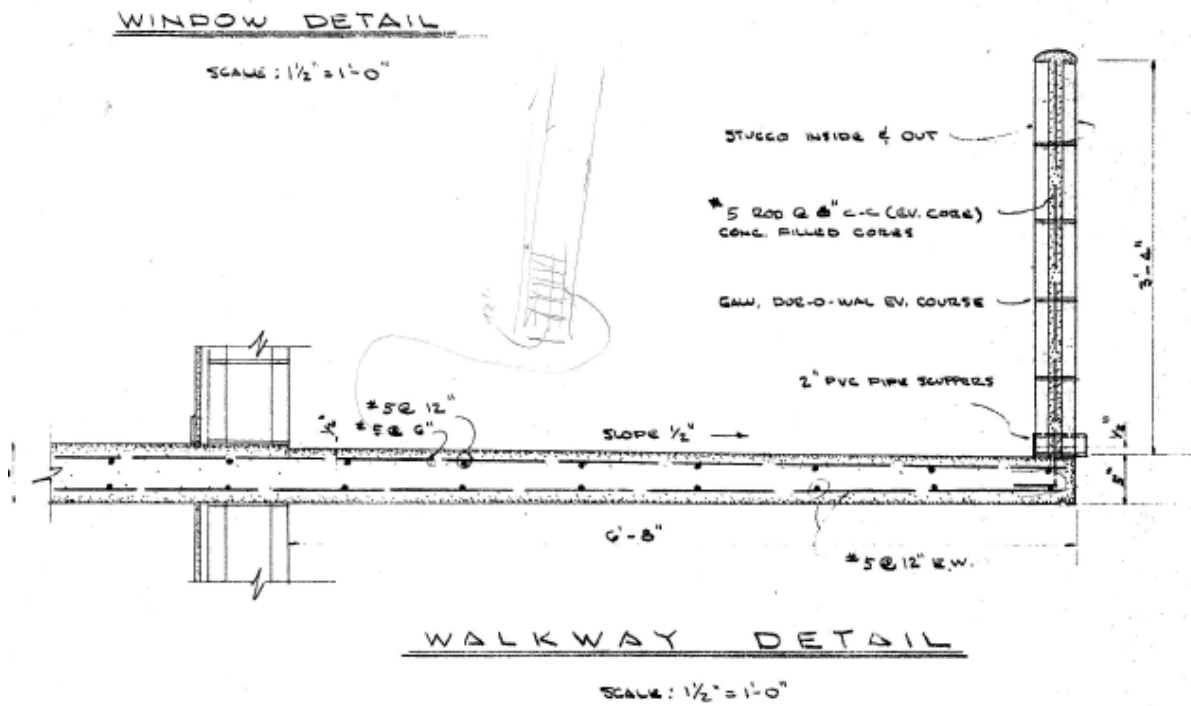
Figure 62 Original walkway configuration

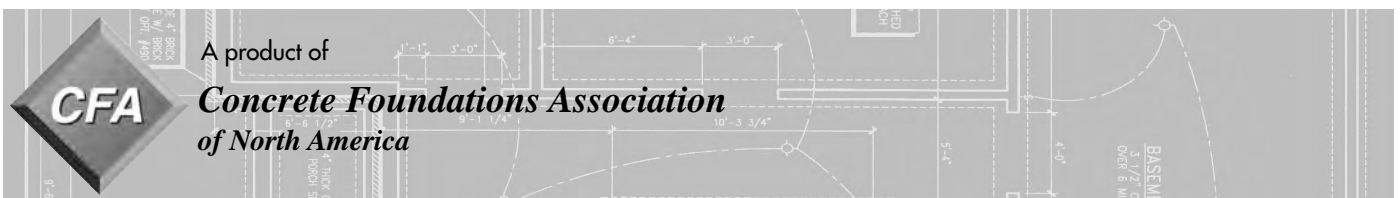
Cracking In Concrete Walls

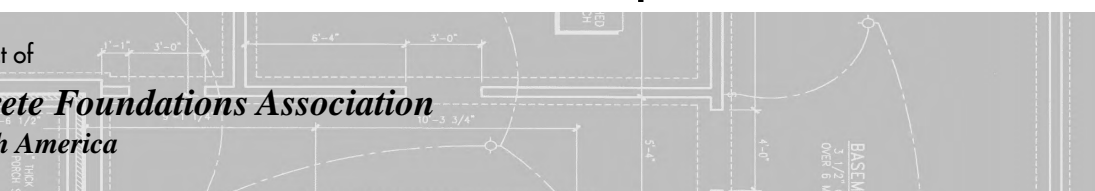
Shrinkage and Temperature cracks are most often vertical to diagonal. They typically emanate from a corner of a window, beam pocket, or other opening. Cracks of this type are called reentrant cracks. These are very common and, unless they leak or show significant lateral displacement, are of no structural concern.

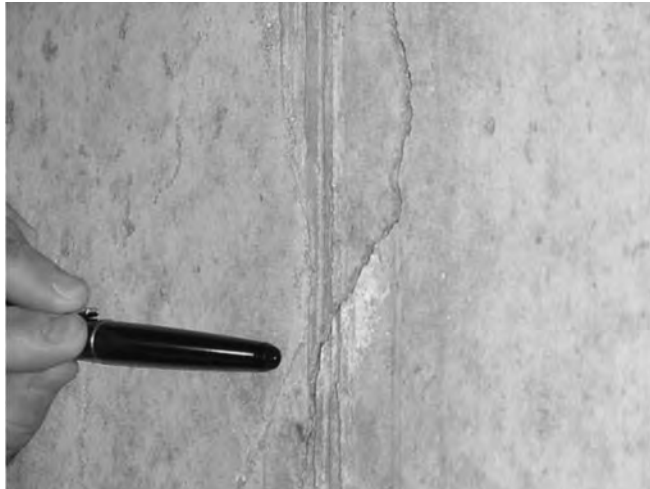
Cracks which are horizontal are most likely caused by an applied load. Vertical cracks which are significantly wider at the top or bottom could indicate heaving or settlement. With these cracks it is very likely that the crack itself is not the problem, but rather the result of an external problem such as poor drainage, overloading, etc.

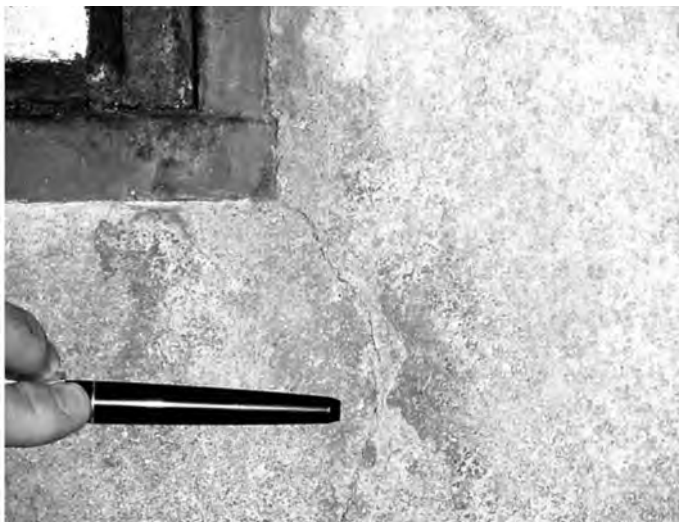
• Minimizing the Problem
